When 155yr old major city sewer collapsed

emergency team restored flow in 3 weeks - repair in 16 weeks

by Dave Young BSc, CEng, MICE, FCIWEM

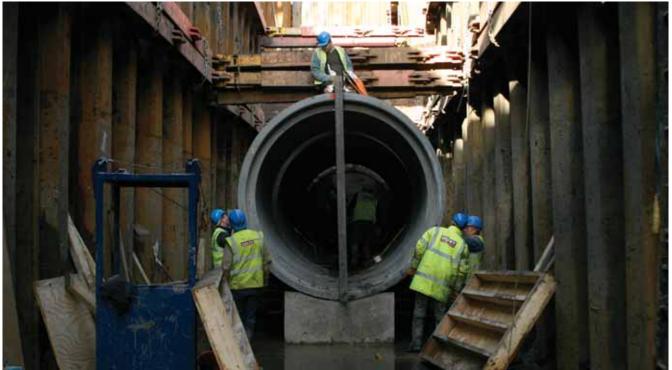
Knostrop Sewer: Placing of concrete pipes - note man standing upright inside pipe

During the design period a further cofferdam was constructed around the suspected area of collapse. Excavation down to the sewer within the cofferdam showed the upstream section to be severely distorted and unable to accept a sleeve of sufficient size placed within it. The steel sheet piling was, therefore, extended, the damaged sewer removed and replaced with 2.4m diameter concrete pipes. These pipes were laid in a special high strength reinforced concrete cradle to achieve an appropriate bedding factor.

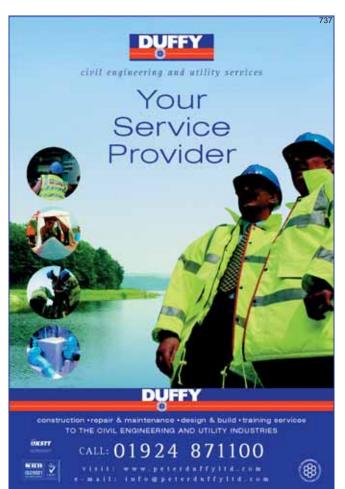
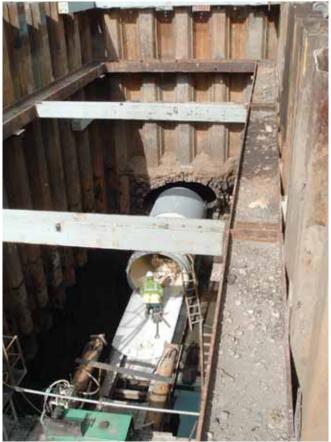
Shield and first pipe prior to jacking within the sewer

The design of the sewer over this section was based on the existing sewer, the infill grout and the GRP pipe acting as one structure. The size of the GRP pipe was determined by a combination of surveying the existing sewer to ensure the proposed pipe would fit (the existing sewer was no longer truly circular with vertical and horizontal deflection of over 300mm being observed) and by design. This involved calculating both the thickness of the pipe required and the effect that the reduced diameter would have on the hydraulic performance of the sewerage system as a whole. Initial investigation works which covered approximately half of the length of affected sewer gave the team confidence that a 1.94metre outside diameter, 70mm thick, GRP pipe would pass through the sewer without causing further damage.
