Monmouthshire & Brecon Canal Restoration Project

works to improve resilience of canal infrastructure, securing embankments, reducing water demand and making habitats bigger and better connected

by Allen Chanda CEng CWEM CIWEM

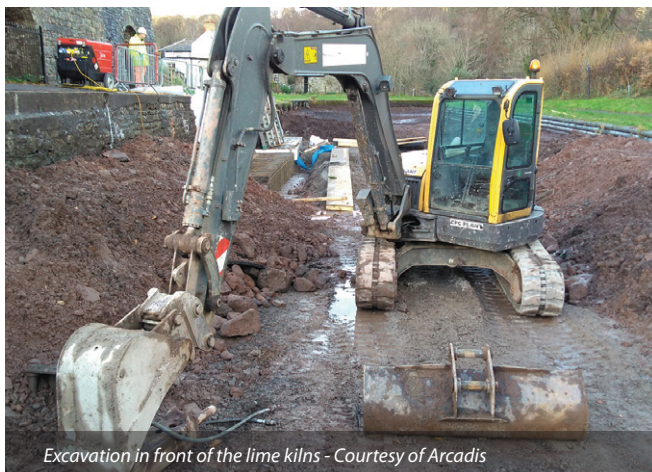
Excavation in front of the lime kilns - Courtesy of Arcadis

The design proposal included retaining the waterway wall in front of the lime kilns (Grade II listed building) and connecting the existing wall and the new wall with dowels. However, during excavation the wall in front of the lime kiln was undermined and it partially collapsed. Following consultation with Canal & River Trusts' heritage advisor, a new reinforced concrete wall with stone cladding (matching the existing in type, colour and texture) was designed and constructed to support the access road and lime kilns above it.

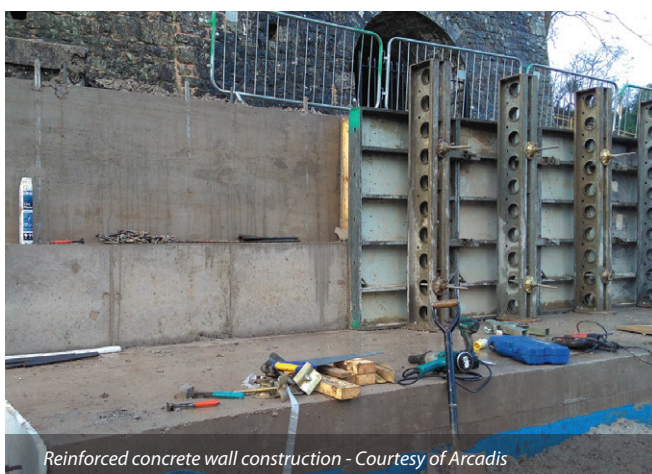
Reinforced concrete wall construction - Courtesy of Arcadis

The reinforced concrete wall (1.8m height and 30m long) and canoe portage access steps were designed to the following standards:

Wallip software was used to prepare the ground model, wall sizing (masonry and reinforced concrete walls) and to undertake stability checks. The Reinforced Concrete Council spreadsheet was used for the structural design of the reinforced concrete wall and the overall factor of safety for sliding and overturning was greater than 1.5.

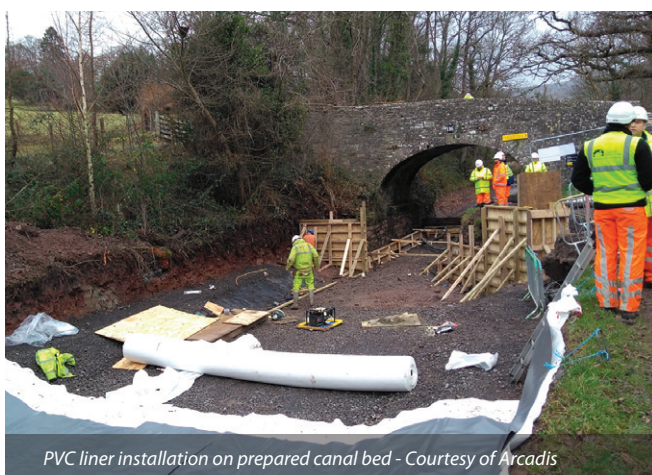
PVC liner installation on prepared canal bed - Courtesy of Arcadis

Construction, installation and jointing of the liner was carried out by experienced, skilled operatives recommended by the manufacturer and approved by CRT. Lining sheets were carefully laid out on the prepared formation free of sharp objects, ruts, protrusions, voids and undulations.

The contractor tested each joint and repaired any that were found to be faulty. Through the main channel invert and on the side slopes, the lining was protected by a 125mm thick layer of mass concrete.

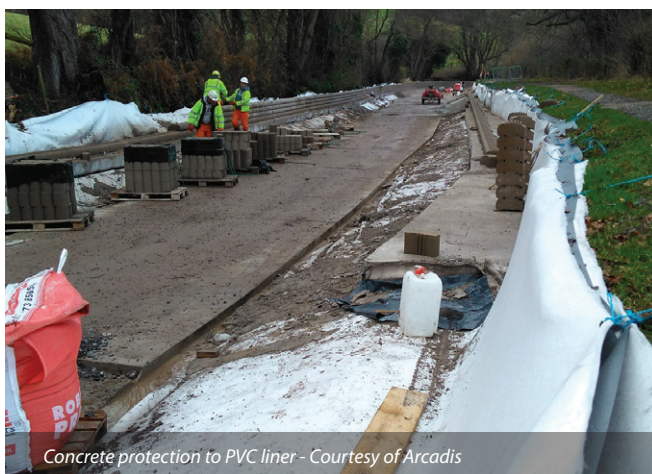
Concrete protection to PVC liner - Courtesy of Arcadis

On completion of all lining works and immediately prior to re-filling the canal with water, the concrete protection layer and side slope protection were carefully inspected to ensure that there were no cracks or depressions which may have threatened the integrity of the liner.
