Usk Spillway Upgrade

extensive spillway improvements to Usk Reservoir and refurbishment of the road bridge for Welsh Water

by Jon Clewer & Karen Morris

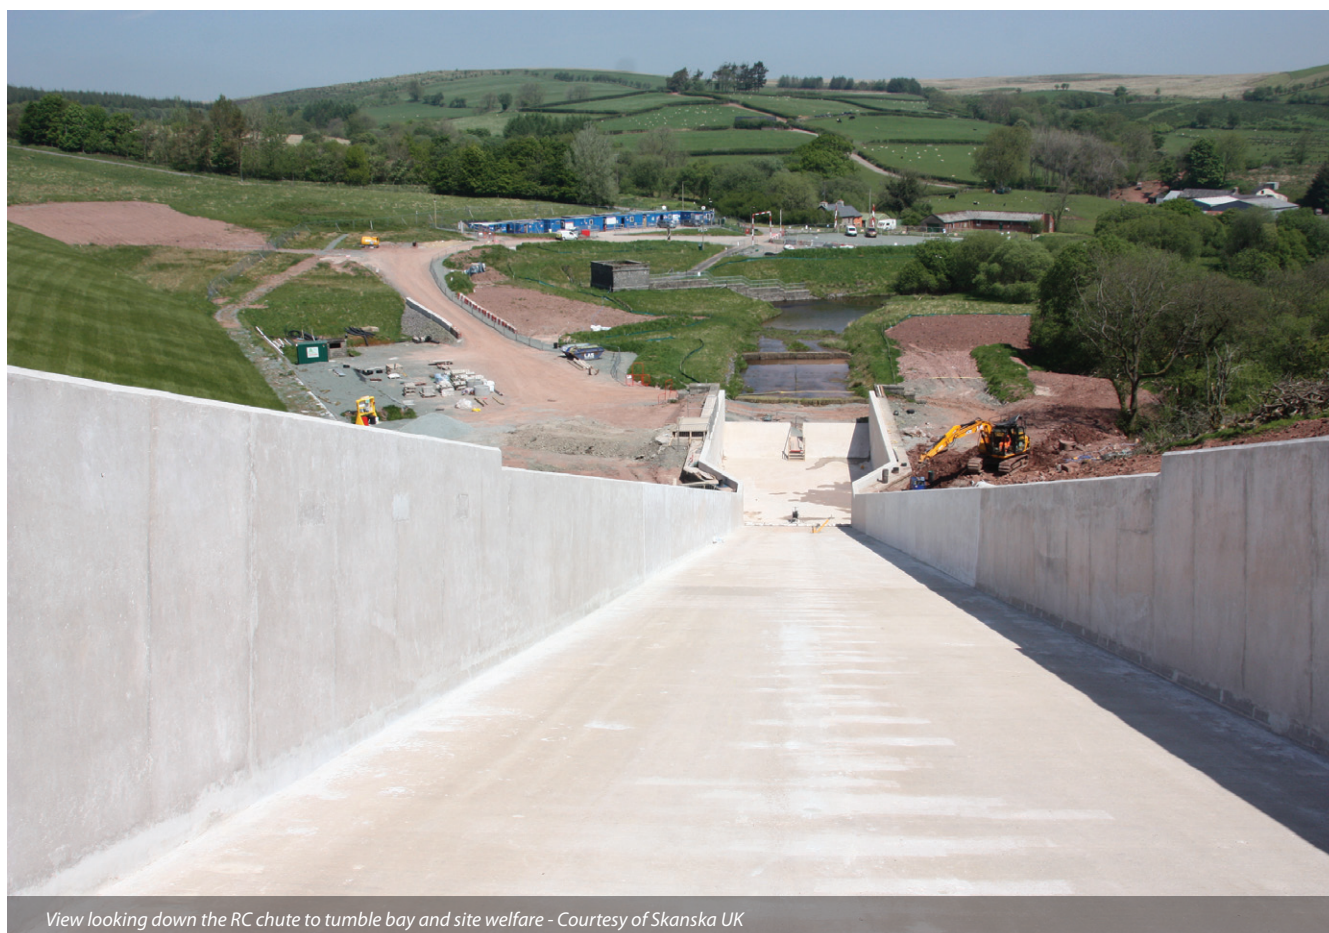
View looking down the RC chute to tumble bay and site welfare - Courtesy of Skanska UK

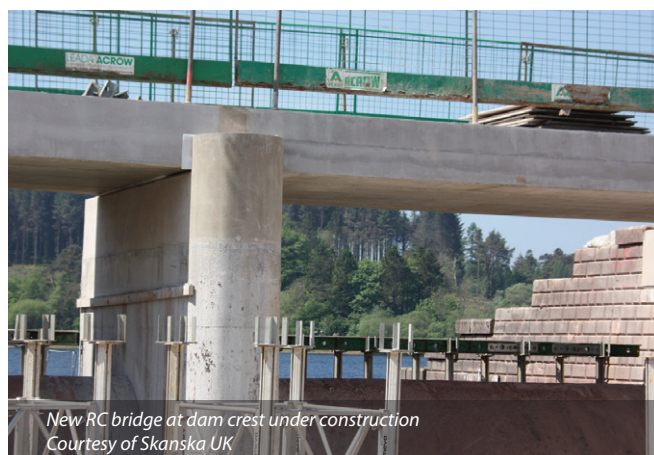
New RC bridge at dam crest under construction
Courtesy of Skanska UK

Works to replace the existing bridge deck were also included in this contract. This included the demolition of the existing bridge deck, to be replaced with a new structure of minimum five tonne capacity, with a raised soffit level giving 300mm freeboard above PMF peak still water flood level (PSWFL).

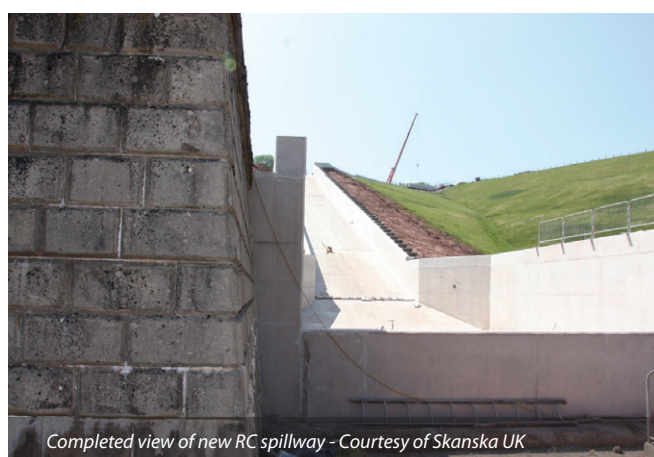
Completed view of new RC spillway - Courtesy of Skanska UK
