# Morpeth Flood Alleviation Scheme Phase 3

## Cotting Burn Dam & Lowford tree poles - delivering sustainable flood alleviation in Morpeth through innovation and materials reuse

by Emily Bradley BSc FdSc

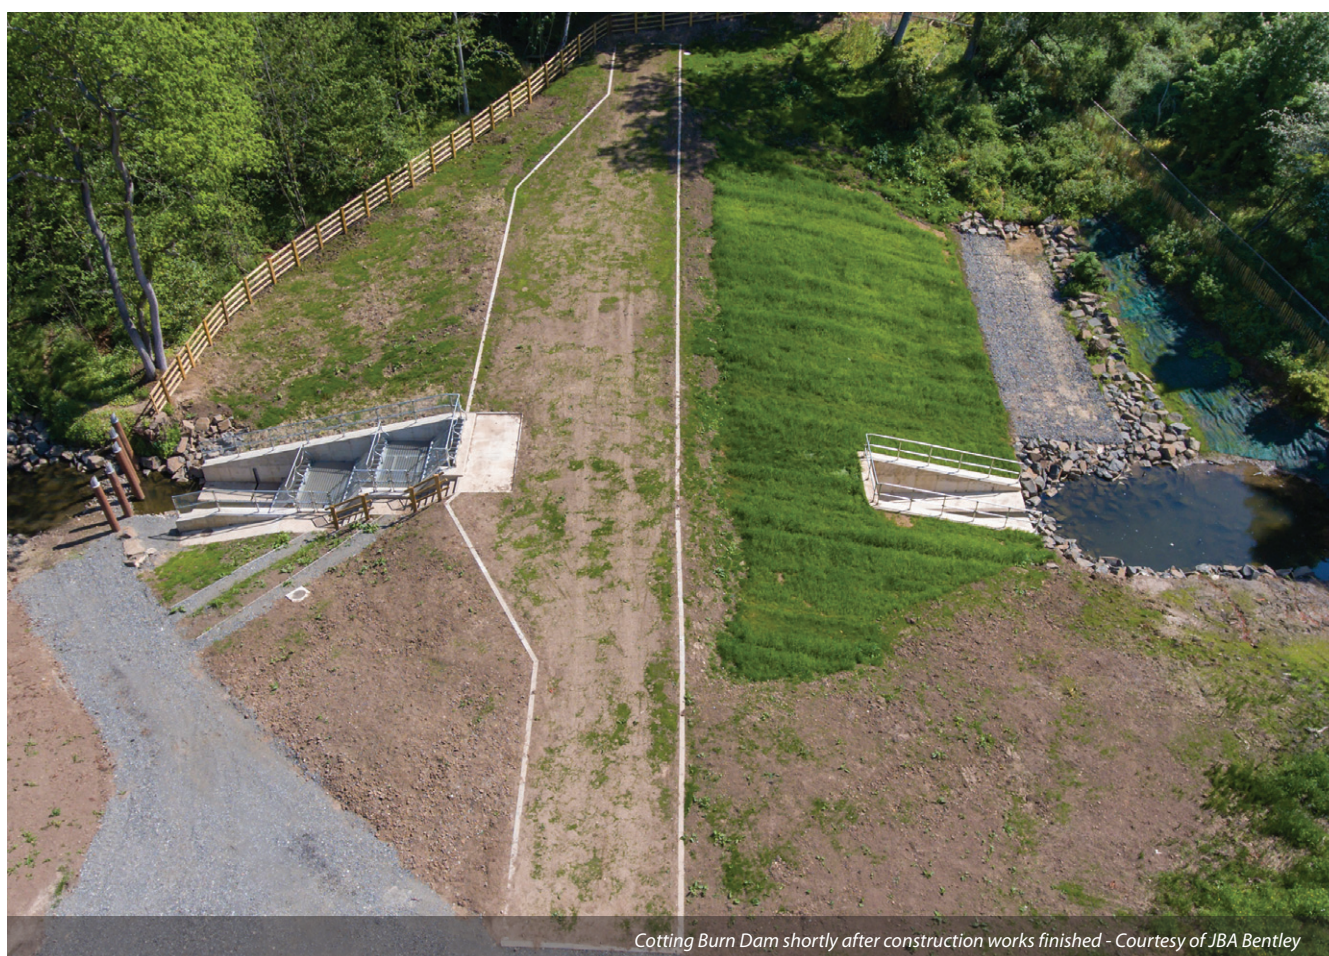
Cotting Burn Dam shortly after construction works finished - Courtesy of JBA Bentley

Providing a standard of protection of 1 in 100 years (protection against an event with a 1% annual exceedance probability) Cotting Burn Dam is an online flood storage area. The dam reduces flood risk by two methods; firstly by impounding water, reducing the flood peak during larger storm events and secondly by reducing the risk of blockage of the culvert downstream. 26 properties are directly protected by the scheme.

The dam is an earth embankment with a 1350mm Ø culvert passing through, conveying Cotting Burn. At the entrance to the culvert is a concrete headwall with a 3-tier trash screen manufactured by JHT Fabrication Ltd. A coarse debris screen was installed just upstream of the culvert to trap larger debris from the wooded upstream catchment. Access has been provided so that the screens can safely be cleared.

Under the ICE's *Floods and Reservoir Safety 4th Edition, 2015*, the dam is classified as Category A, 'where a breach could endanger lives in a community'. As a Category A dam, it must be designed to safely convey the probable maximum flood (PMF). To safely pass the PMF the crest is designed to overtop in a centrally aligned spillway arrangement. Any overtopping will be short duration, therefore shear stress turf was used as erosion protection on the downstream slope of the dam. On the downstream toe of the dam, a capture channel was constructed using rock armour and rock mattress to train the flow back into the natural channel during overtopping.

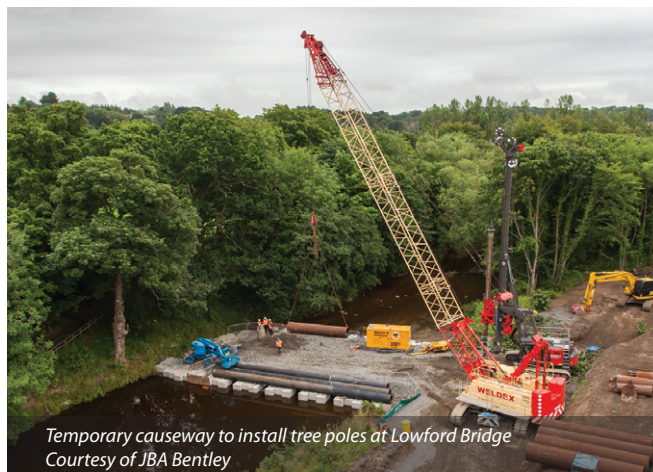
Temporary causeway to install tree poles at Lowford Bridge  
Courtesy of JBA Bentley

To minimise disturbance to the river bed during the piling operations, a temporary causeway was constructed across the channel to create a dry working platform. The causeway was constructed from a number of precast concrete blocks which ran parallel with 6 (No.) 600mm Ø HDPE pipes. Clean stone was used as pipe surround and to provide a running surface for machines. The pipes enabled flow to be maintained throughout the works. Once completed some of the concrete blocks were utilised on site and the others were reused on other local sites. This method caused minimum disturbance to the natural channel and made use of reusable materials.

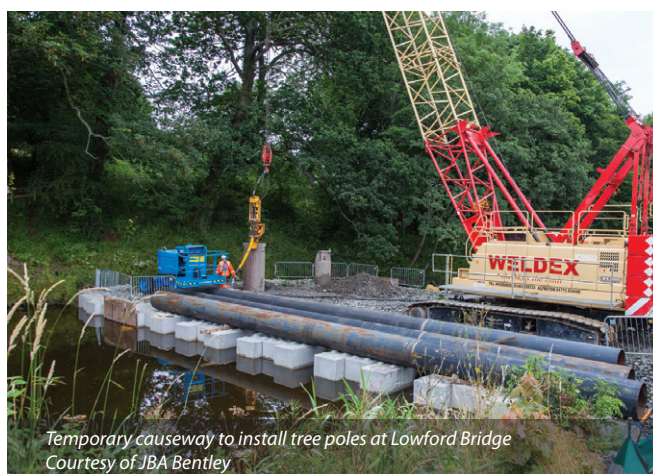
Temporary causeway to install tree poles at Lowford Bridge  
Courtesy of JBA Bentley

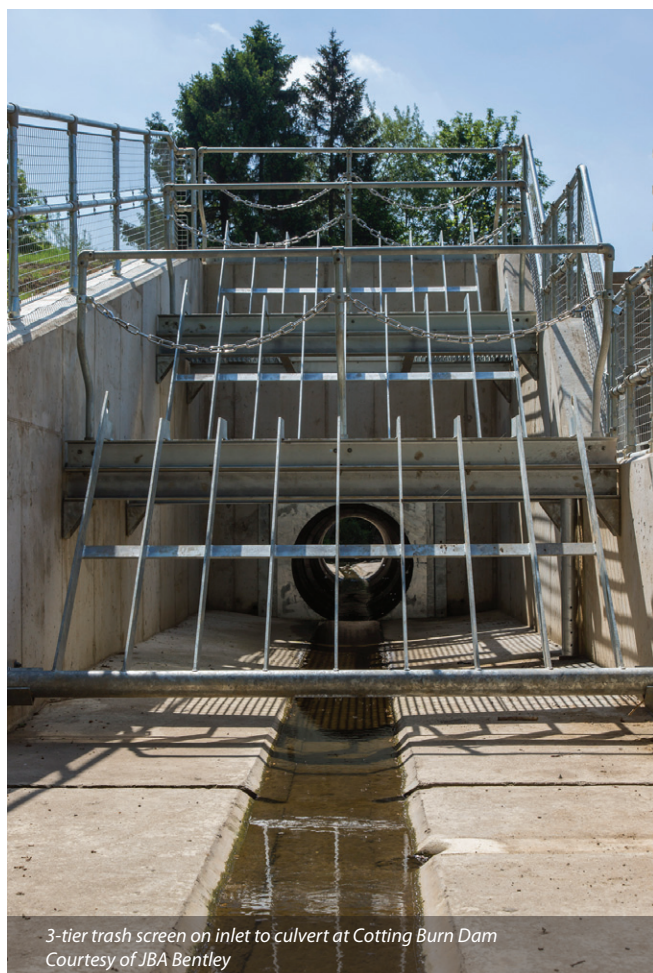
3-tier trash screen on inlet to culvert at Cotting Burn Dam  
Courtesy of JBA Bentley

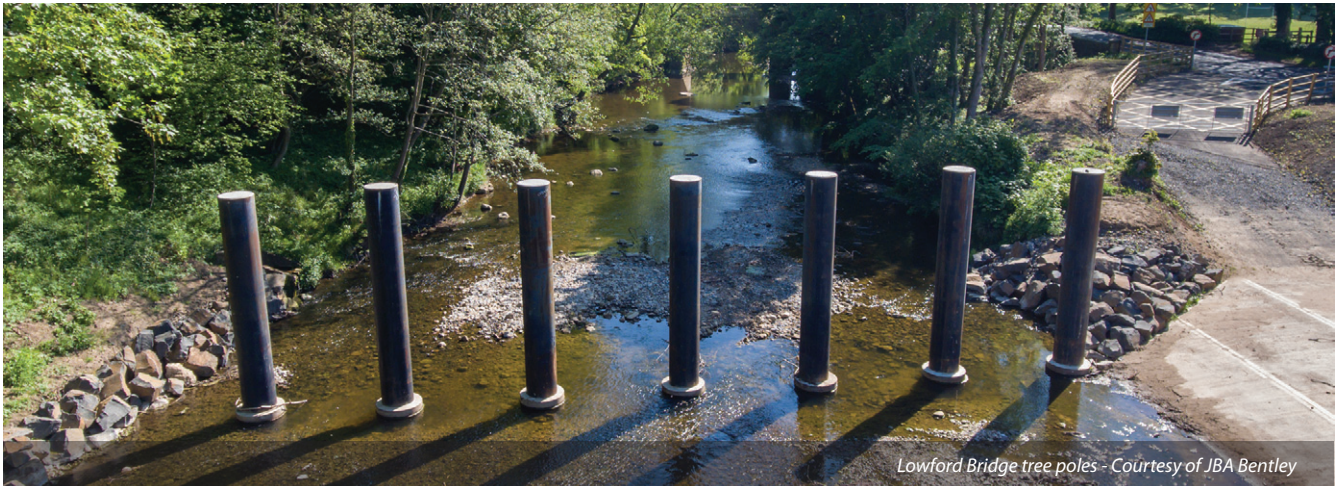
Lowford Bridge tree poles - Courtesy of JBA Bentley

Designed to take debris loading up to the 200-year flood event (0.5% annual exceedance probability) the coarse screen consists of 7 (No.) 711mm Ø CHS tree poles, 17m long. Piling works were undertaken by McGratton Piling Ltd. To ensure the poles were

driven straight and on the correct alignment, holes had to be pre-bored with a steel casing inserted to keep the bore open in the soft alluvium material at the surface. Once driven to depth the CHS were backfilled with concrete. The tree poles stand circa 5.5m above bed level.

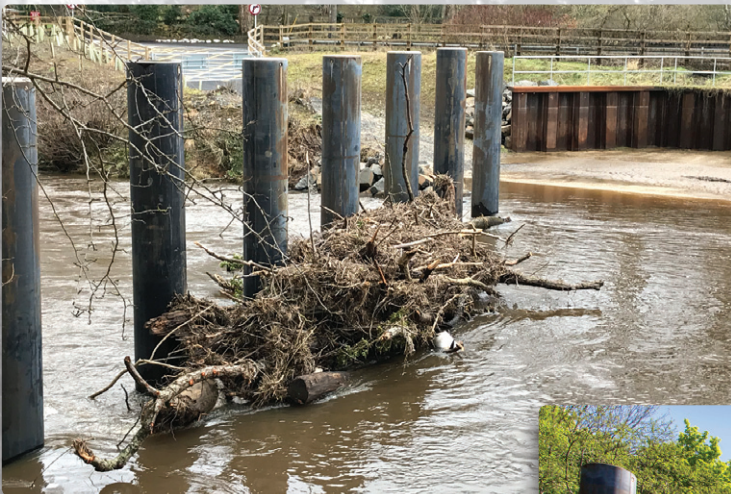
Tree poles in action  
Courtesy of JBA Bentley

There are several bridges through the centre of Morpeth where large floating debris has become trapped, blocking bridges, reducing conveyance and raising water levels resulting in flooding to the town centre as well as potentially causing structural damage to the bridges. To prevent this debris accumulation, JBA Bentley was tasked to design and build a coarse debris screen across the River Wansbeck, just upstream of Lowford Bridge, to trap large debris. JBA Bentley is a joint venture between JBA Consulting Ltd and JN Bentley Ltd.

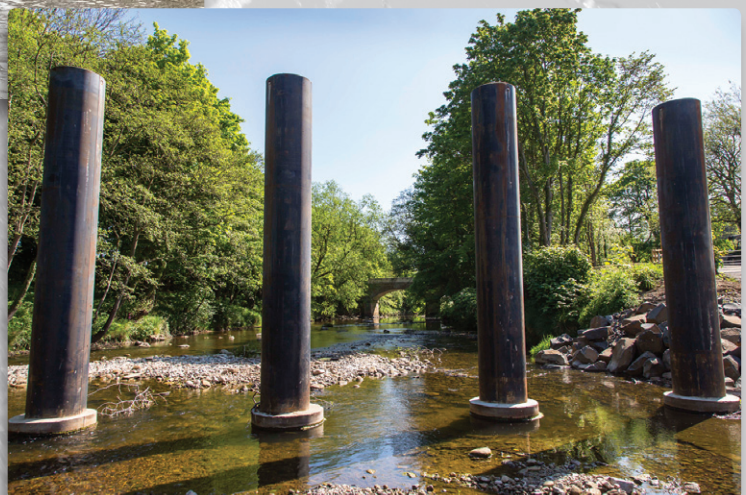
Tree poles with Lowford Bridge in the background  
Courtesy of JBA Bentley
