Basalt sewer rehabilitation projects demonstrate the benefits of basalt

Case study: Prague 'A' Sewer

Case study - Prague Sewer - Trojská Street

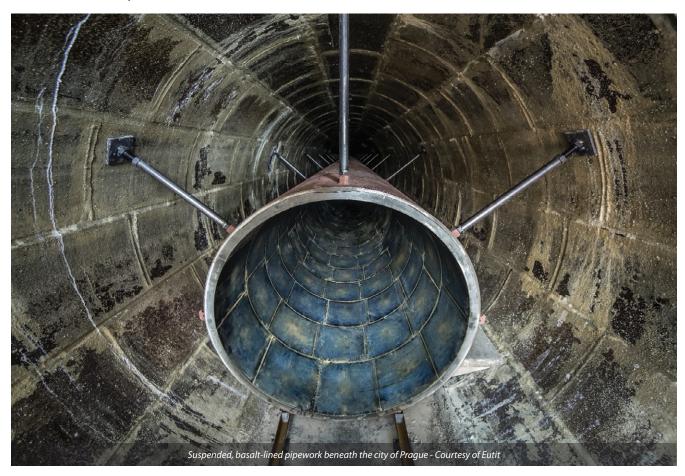
Thanks to its excellent durability, chemical resistance and abrasionresistant properties, cast basalt was selected to repair the bottom of the sewer and sidewalls within the system. While the sidewalls were refurbished by bedding and bonding cast basalt segments over the original brickwork, damaged gutters from the bottom of the sewer were removed and replaced with new cast basalt guttering.

The cast basalt lining system was tied into the structure by installing an L-shaped finishing block, the shorter side of which was fixed and bonded into the milled groove in the existing brickwork. The castbasalt blocks were then fixed and bonded using a special chemical and water-proofed adhesive compound.

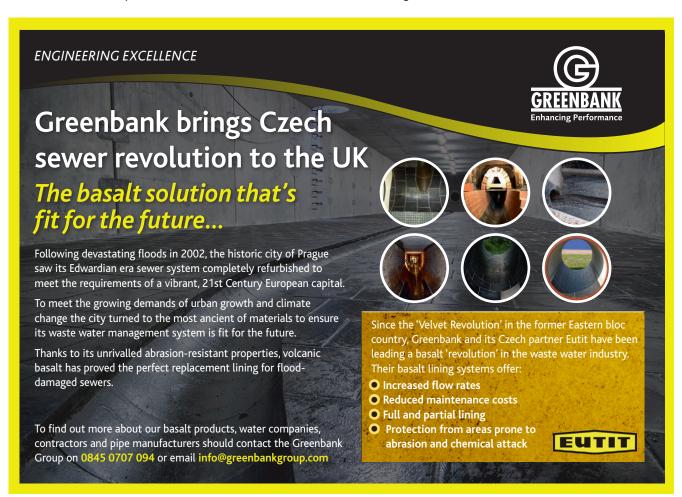
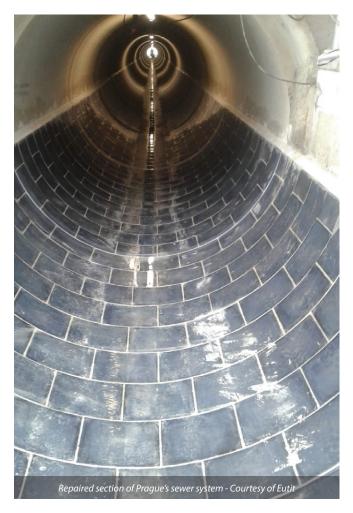
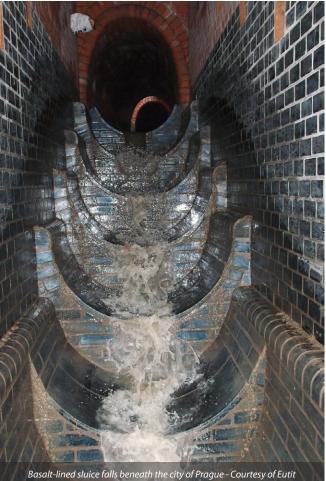
In the extensively damaged sections, and in those sections in which the sewer construction was completely destroyed, the engineer recommended excavating the sewer along its original route.

This excavation would be coupled together with the removal of the remaining structure of the header, which would be replaced by a completely new structure. The engineer also proposed installing cast-basalt gutter segments at the bottom and sides of the sewer, along with installing cast-basalt interlocking side panels. Despite basalt being more than suitable for direct adhesion to concrete, it was decided for extra security that the side panels be tied into the surrounding rock with anchor bolts. The remaining part of the structure was designed and built as a traditional brick sewer.

- In the areas in which it was mainly only the bottom part of the header that was damaged, the project engineer proposed the demolition of the entire bottom part of the header. The existing masonry would be underpinned alongside the installation of an entirely new bottom part for the header. This installation would again utilise cast-basalt gutters and side panels.

- The section of the header with the 100/175cm flow profile and the highest gradient between 5 and 9.8% was designed to be renovated by using the sewer-in-sewer technology. This technology consists of lining the existing sewer with cast-basalt gutters and segments that are interlocked across the entire flow profile. The space between the basalt liners and the existing sewer construction was designed to be back-filled with concrete, whilst the roof was filled with shotcrete. Although this technology decreased the flow profile, it was selected due to its hydraulic conveying benefits.

- The upper sections of the header that suffered from either normal wear and tear or minor defects were designed to be repaired in situ. After milling the joints, the brickwork was repointed and the damaged stoneware gutters at the bottom of the sewer were replaced with cast basalt.
