# Llyn Brenig Reservoir

## reservoir safety works to improve the reliability and robustness of the scour and emergency drawdown system

by Chris Willis

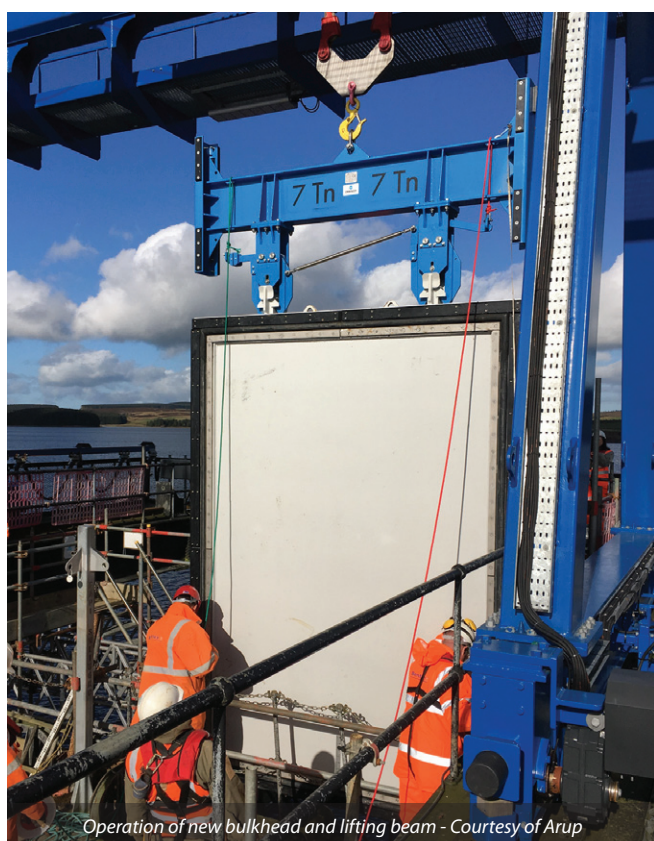
Operation of new bulkhead and lifting beam - Courtesy of Arup

The design criteria of the existing bulkhead gate could not be identified from available record information. The condition was known to be deteriorated, and the sealing system was performing poorly. As this gate would act as the single point of isolation during works to replace the original scour gate and frame, the decision was made to provide a replacement bulkhead gate designed to a safety factor (SF) of 1.5 minimum for all load cases, with new seals and an improved bottom edge design to aid seating in the submerged

slot at the base. The design of the new bulkhead gate was proven by calculation to exceed the specified safety factor. Finite element analysis (FEA) considered various loading conditions, including partially seated and failed to close fully scenarios.

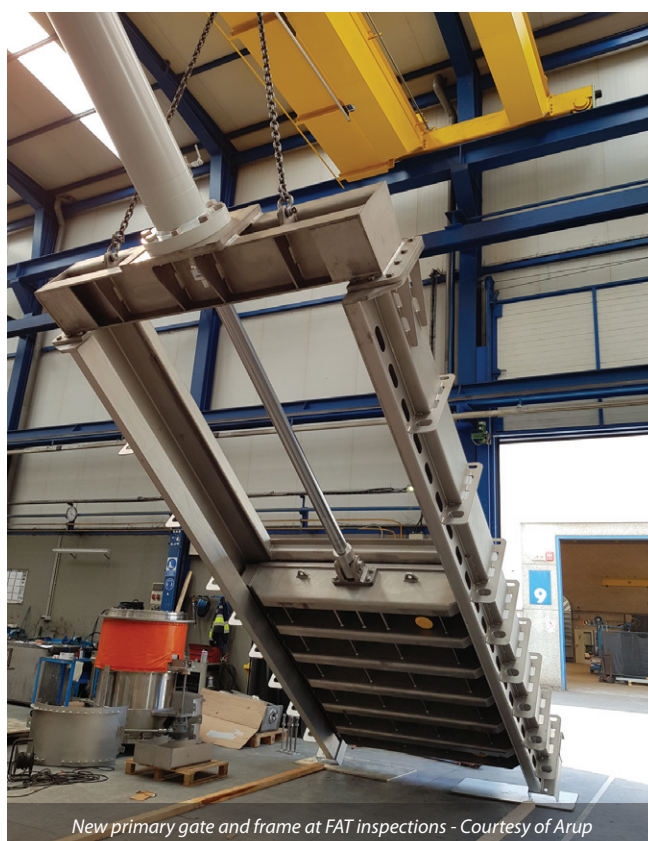
New primary gate and frame at FAT inspections - Courtesy of Arup

The existing scour gate was to be replaced with a new primary scour gate; a 2.4m x 2.5m hydraulically actuated fixed wheel roller gate fabricated in full stainless steel to extend the design life. Although the initial proposal was based on replacement of the original scour gate only, on surveying and inspection of the normally inaccessible parts of the original frame, it was found to be of an outdated sealing design, and in such deteriorated condition on the upstream faces that it could not be modified or re-purposed to provide an acceptable seal.

Arup undertook a thorough investigation to identify the details of the original frame and how it was tied into the structure and developed a procedure for its removal without compromising the structural reinforcement. The design of the new frame and anchoring arrangement needed incorporate the various requirements of transferring and distributing loads into the existing structure, constructability challenges, and ensuring reliable gate operation. The development of the gate and surrounding structural works design and construction sequence was therefore a thoroughly collaborative process between Arup, MMB and Orbinox (manufacturers of the gate).

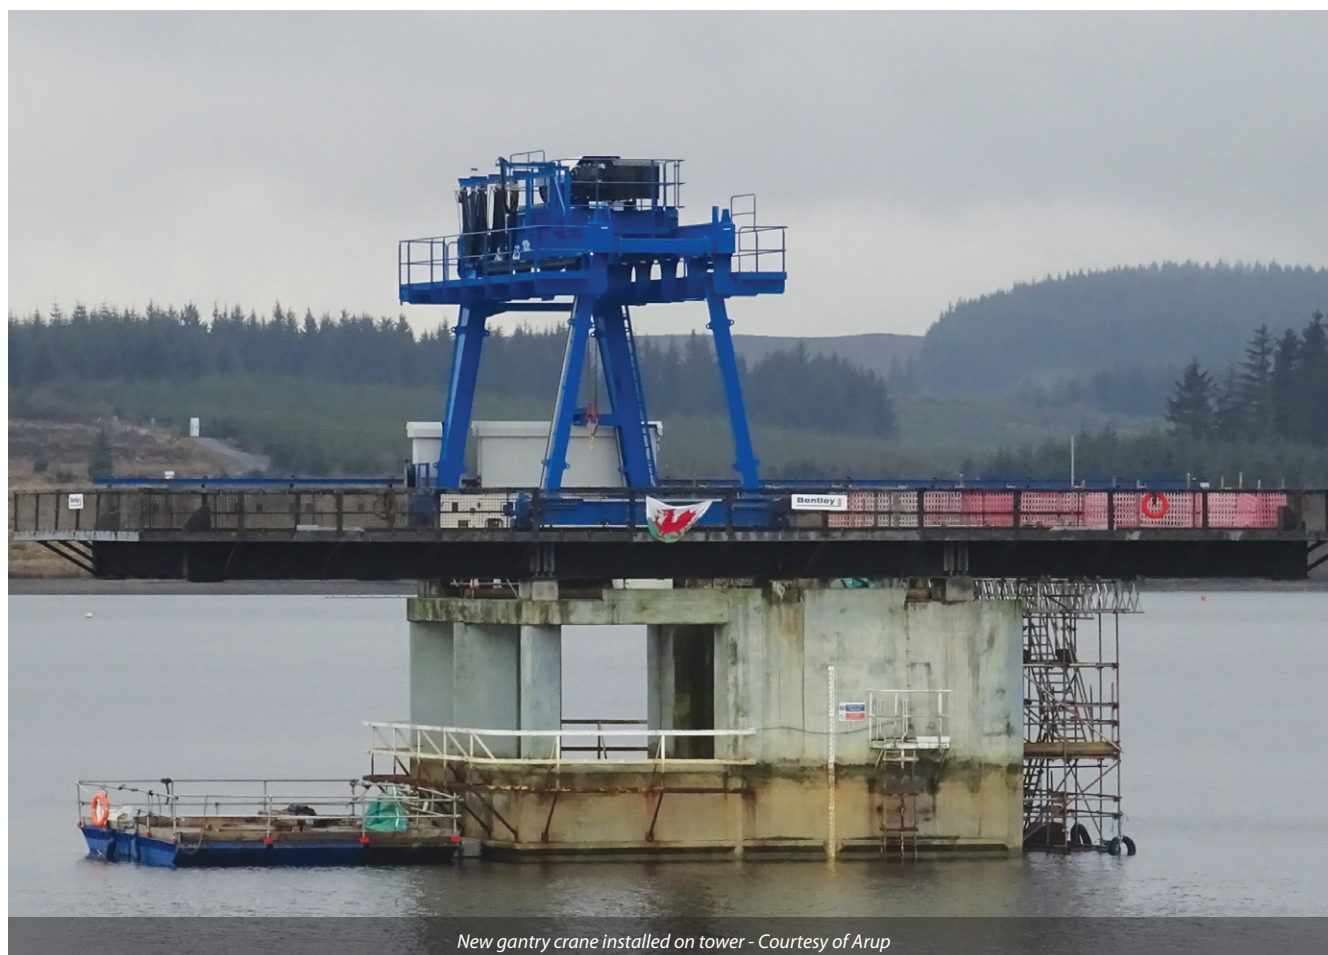
New gantry crane installed on tower – Courtesy of Arup

The goliath crane was to be replaced with a new gantry crane of the same rating to allow safe remote operation using a wireless pendant. Arup completed a structural assessment on the existing gantry structure to identify its suitability for the proposed new crane plus the maximum payload at the extremes of travel. The structures anchor points and support plinths were to be upgraded.

A structural assessment confirmed that four of the six concrete plinths supporting the crane required replacement. MMB engaged with specialist contractor Freyssinet to design and implement temporary works to support the existing 26t crane and supporting steelwork whilst works were undertaken.

Replacement of the crane required the use of a stabilised crane on deep water. MMB worked closely with Red7Marine to develop a temporary solution, positioning a mobile crane on a pontoon 150m off the shoreline without requiring complete anchoring to the 50m deep reservoir bed. Instruction from the All Reservoirs Panel Engineer (ARPE) was that the pontoon should be completely isolated from anchoring to the tower and embankment dam.

A temporary works design and methodology was developed between MMB, Red7Marine and the ARPE which included a 100t telescopic crawler crane positioned on a 324m<sup>2</sup> floating pontoon anchored back to the existing shoreline with circa 250m long wire anchor ropes and 10t anchor points. Extensive stability checks considering wind loading and wave action were carried out which largely contributed to the huge success of this activity.

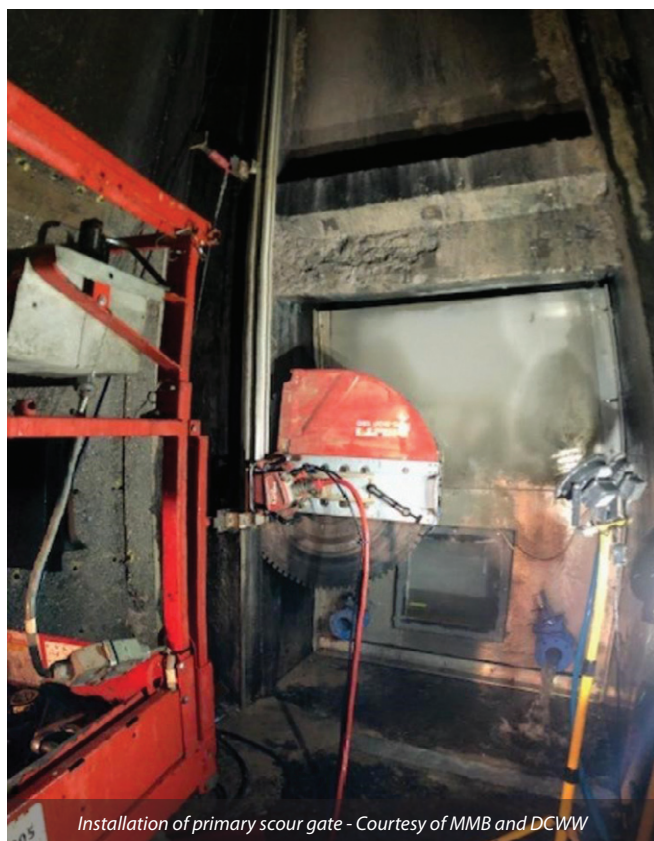
Installation of primary scour gate - Courtesy of MMB and DCWW

The activity which posed the greatest health and safety risk was the replacement of the primary scour gate, which involved intrusive concrete removal works to the existing tower whilst working behind a single isolation point from the reservoir. These works were undertaken through the DCWW Gold Command structure.
