Usk Spillway Upgrade

extensive spillway improvements to Usk Reservoir and refurbishment of the road bridge for Welsh Water

by Jon Clewer & Karen Morris

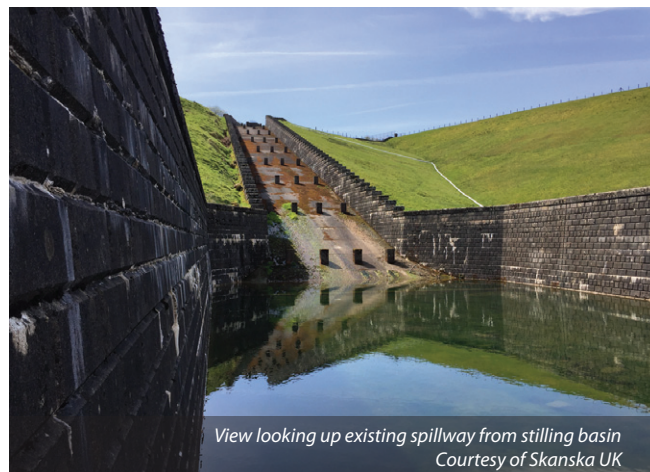
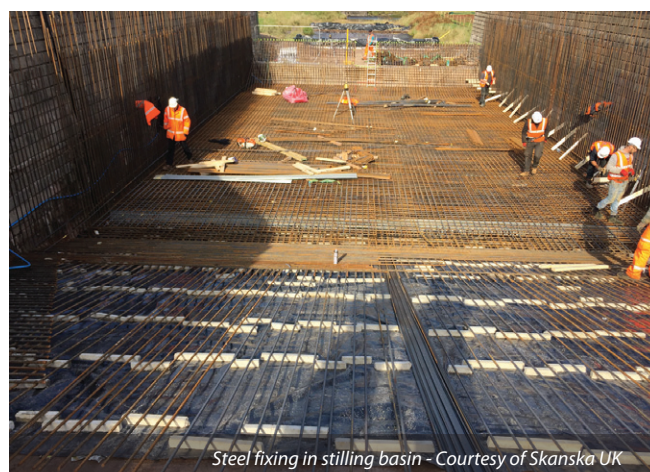
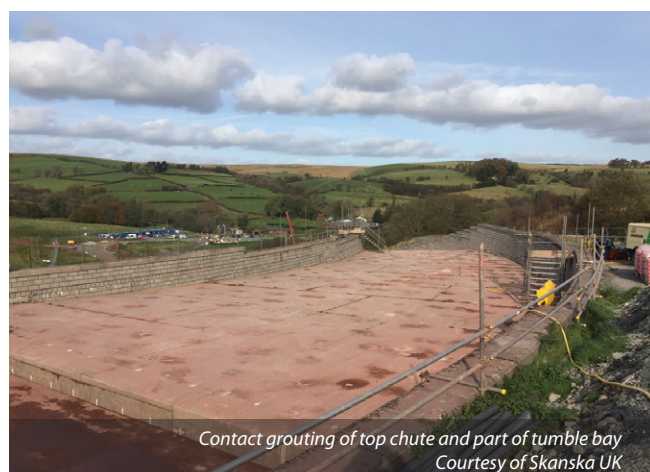
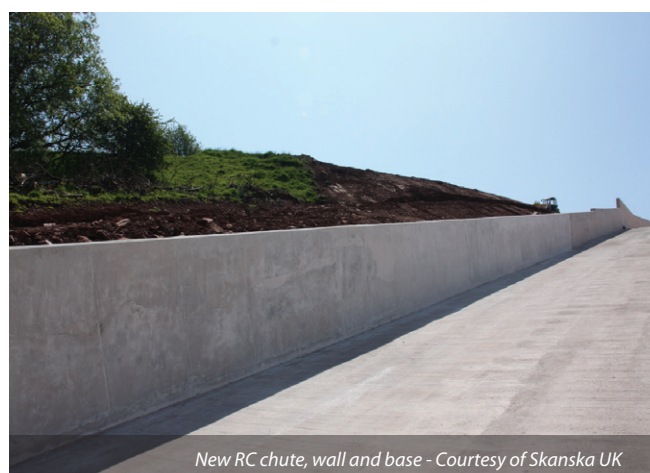
Tumble bay: The tumble bay required contact and consolidation grouting works to fill voids and improve rock mass quality under the spillway base slab. This included gravity grouting to reinforce the connection between the concrete cut-off wall and clay core to the left of the spillway bridge, and pressure grouting of the connection between the existing concrete cut-off and rock foundation under the spillway weir and sufficient grouting to seal the grout curtain to depth.

The work also included breaking out of the downstream toe of the existing weir to form a vertical construction joint with the new lining, removal of masonry facing to the existing spillway walls to create a recess for the new spillway lining and breaking out of the

existing spillway base slab along the existing tumble bay walls and building up in mass concrete, to a new lower formation level for the new lining works. A reinforced concrete watertight lining (Class 1 to BS EN 1992-3:2006) to the existing tumble bay (walls and base slab) was constructed to fully contain PMF flows, including wall raising. The thickness of the new tumble bay walls is 450mm, and the base slab was thickened to 450mm.
