New River, Hertfordshire

new lease of life for 400yrs old water supply aqueduct

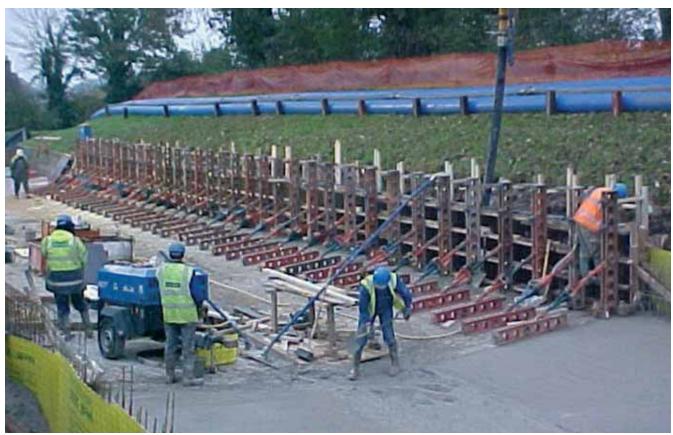
New River: Construction of new walls - overpumping pipes on embankment

Another significant difficulty was the temporary over-pumping of the flow in the New River. This flow - which can be as high as 180Mld - was overpumped using 3no. 450mm diameter pipes which had to be routed under an existing road bridge to avoid interfering with the construction site.

Two temporary dams were inserted to allow de-watering of approximately 100m of the New River channel. Over pumping was achieved via three pumps supported in the upstream channel on a temporary A-frame. This arrangement allowed the new concrete channel to be constructed entirely in dry conditions, and also facilitated an internal inspection of critical parts of the 1990's channel. Permanent shutters were used in the construction of the new walls of the channel (see photo 3).
